HYDRAULIC MODEL INVESTIGATION LIBBY DAM KOOTENAI RIVER
MONTANA HYDRAULIC... (U) ARMY ENGINEER DIV NORTH PACIFIC
BONNEVILLE OR DIV HYDRAULIC L... L Z PERKINS ET AL.

4. TITLE (and Subtitle) LIBBY DAM, KOOTENAI RIVER, MONTANA Hydraulic Model Investigations		5. TYPE OF REPORT & PERIOD COVERED
7. AUTHOR(s)		6. PERFORMING ORG. REPORT NUMBER

LIBBY DAM, KOOTENAI RIVER, MONTANA
Hydraulic Model Investigations
PART I: INTRODUCTION

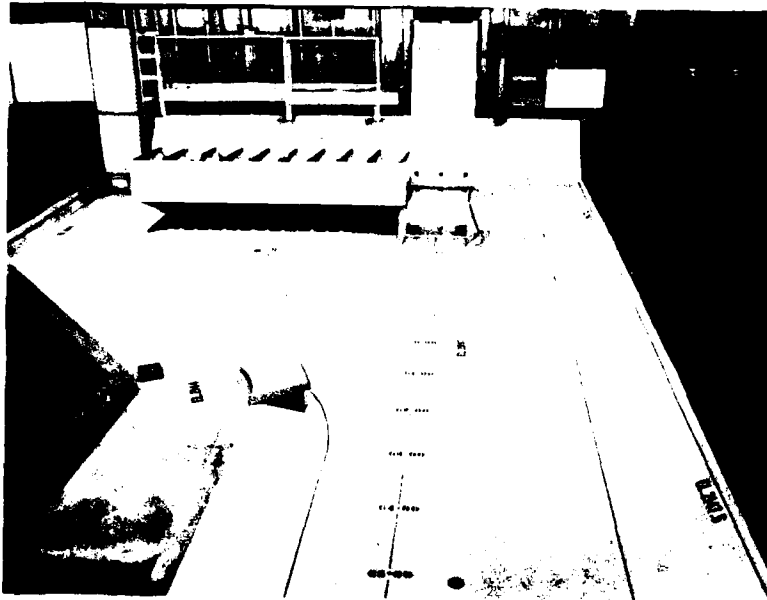
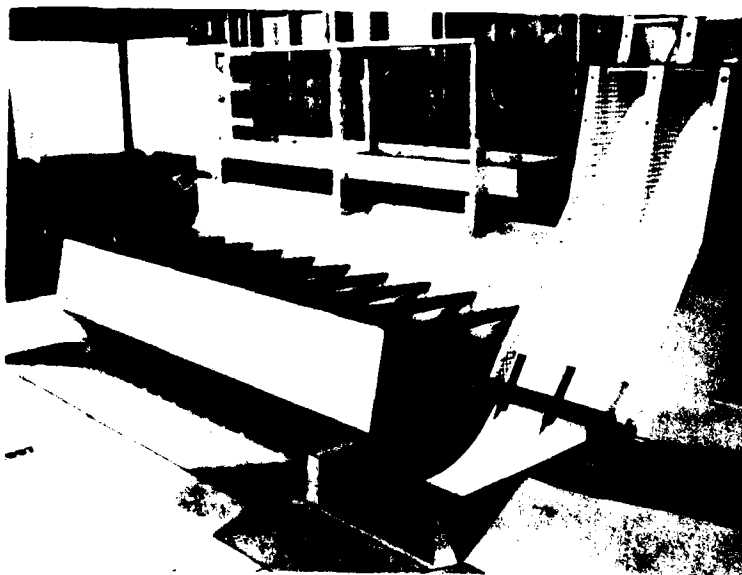
View looking upstream

Spillway and powerhouse

Photograph 1. Plan A (original design) structures and tailrace in 1:50-scale spillway model.

8. Three models were used in the studies. A portion of the forebay, the spillway, sluices, and powerhouse, and 1,600 feet of exit channel were reproduced in a 1:50-scale model for general study of the spillway, exit channel, and diversion during construction (photograph 1 and plate 4). A separate 1:50-scale model was used to study methods to reduce high levels of nitrogen in flow downstream from the project. This model included the spillway, sluices, stilling basin with runout slope, and a 200-foot-wide by 400-foot-long section of downstream channel (photograph 2 and plate 5). In both models all open-channel sections of sluices downstream from the valves were modeled. The intake of the right regulating sluice was reproduced in a 1:20-scale model (plate 6). The model reproduced a portion of the forebay and upstream face of the dam and included the intake bellmouth, emergency gate slots, and valve section; the valve was not included. The model forebay consisted of two closed steel tanks that allowed the full head of 247.7 feet (12.4-foot model) on the intake to be reproduced. The test bellmouths were precision castings of epoxy material (photograph 3).

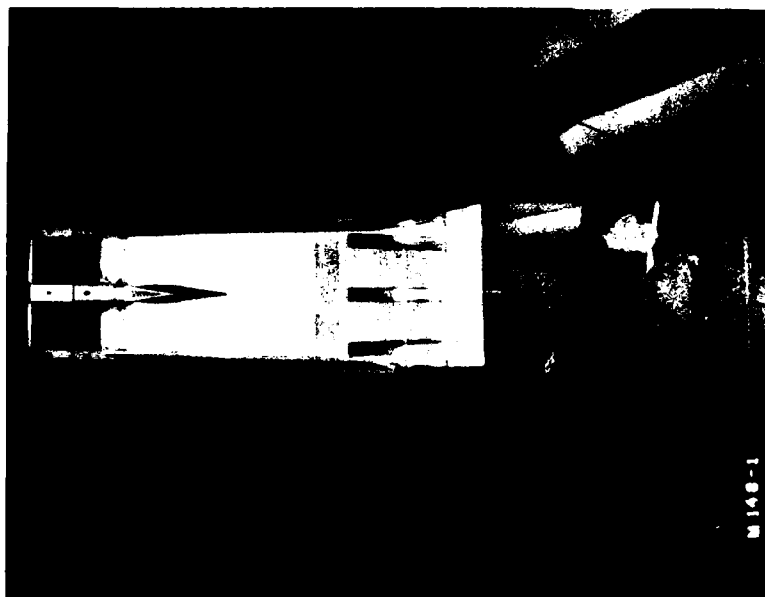
View looking upstream

Side view of stilling basin, runoff
slope, and excavated tailrace

Photograph 2. The 1:50-scale spillway model used for nitrogen reduction studies.

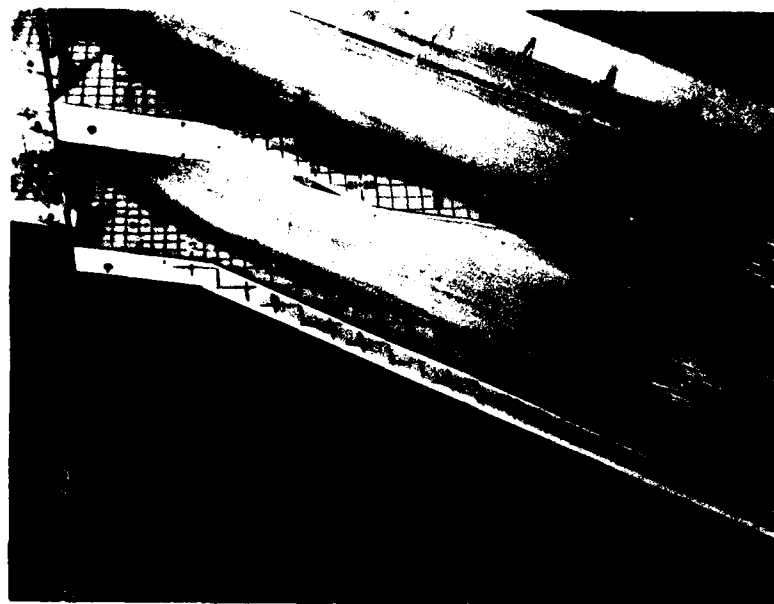
Spillway discharge 145,000 cfs, free flow; no overtopping of pier extension

Spillway discharge 110,000 cfs, gate opening 32.8 ft, occasional overtopping of pier extension

Photograph 6. Flow conditions with plan B pier and abutments and plan A-1 pier extension.

22. The Plan A-1 pier extension was not overtopped by a free flow of 145,000 cfs (photograph 6). The upstream corner of the extension was occasionally overtopped during a gated flow of 110,000 cfs. The overtopping flow followed the narrow edge of the pier extension to about station 51+15 and did not spill into the center void. This plan was adopted for use in the prototype.

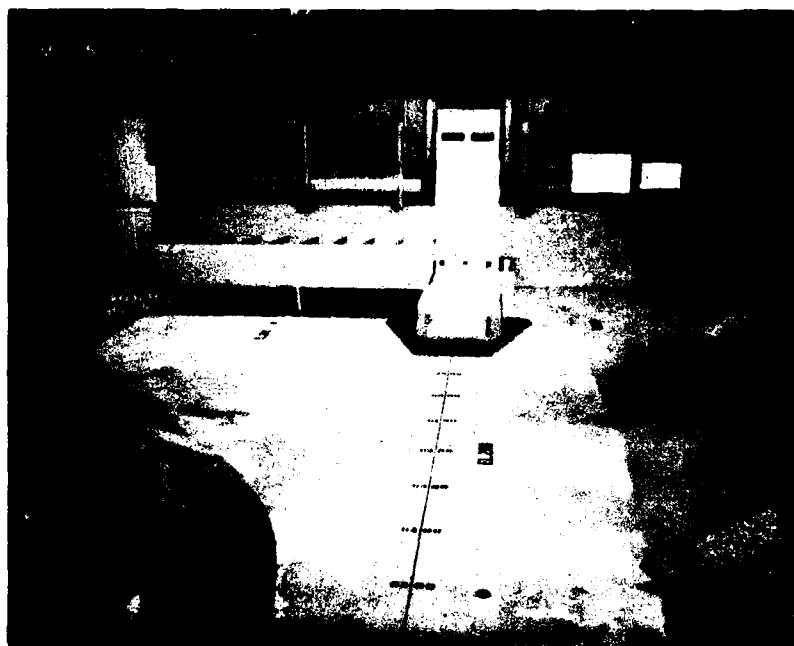
Photograph 12. Plan G downstream channel with plan D-1 stilling basin.

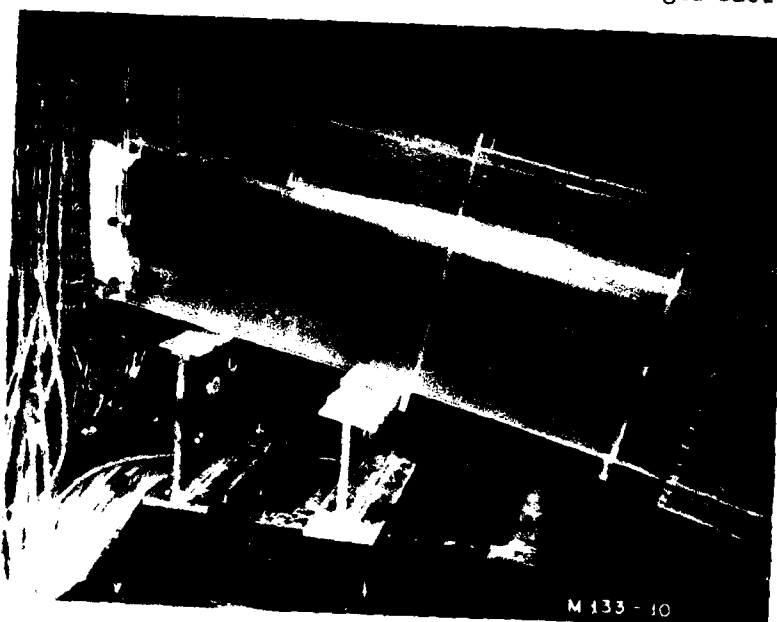
Plan F
Flow separation caused by impingement in right slot

Plan G

Photograph 13. Flow conditions with bellmouth plans
F and G. Free flow, pool elev 2459.0.

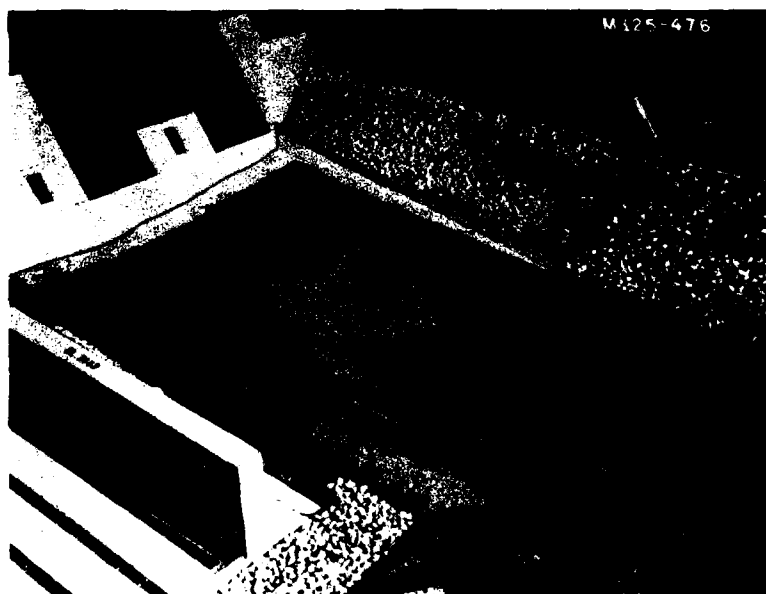
View from downstream

Derrick stone on stilling basin runoff
slope and riprap along left bank

Photograph 14. First-step, second-stage diversion structures
and downstream channel (before scour tests).

49. Details of the recommended plan (Plan F diversion) are shown in photographs 14 and 15 and on plate 48. The structural changes included: (1) replacement of the sluice in Monolith 36, which spilled onto the left bank, with one in Monolith 31, (2) provision for stop-logs near the downstream end of Monolith 33 to cause the outflow to plunge, spread, and dissipate energy better, and (3) addition of a low wall along the left bank adjacent to the dam. Excavation around the structures which was riprapped and backfilled in Plan A was left open. The derrick stone on the left bank above the toe wall was grouted, and the derrick stone and riprap on the remainder of the downstream bank slopes were loose-dumped.

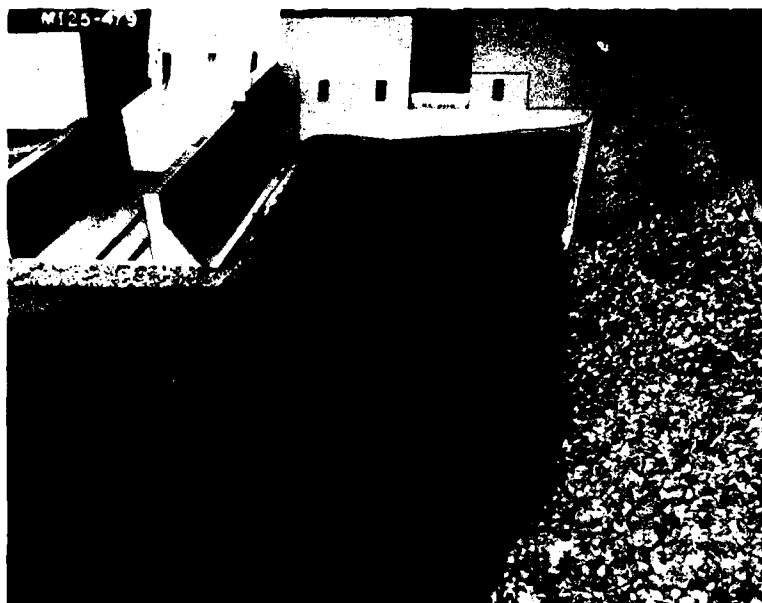
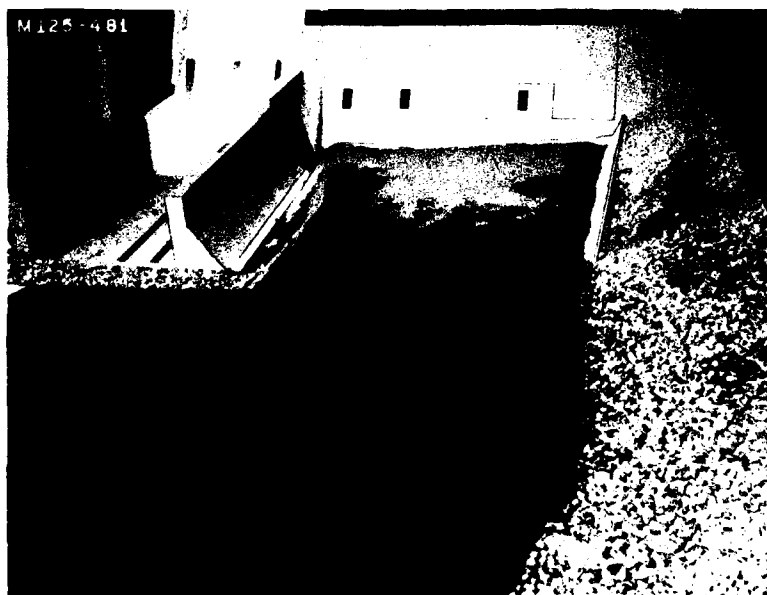
Second-step, second-stage diversion

Third-stage diversion

Photograph 15. Diversion structures and downstream channel (before scour tests).

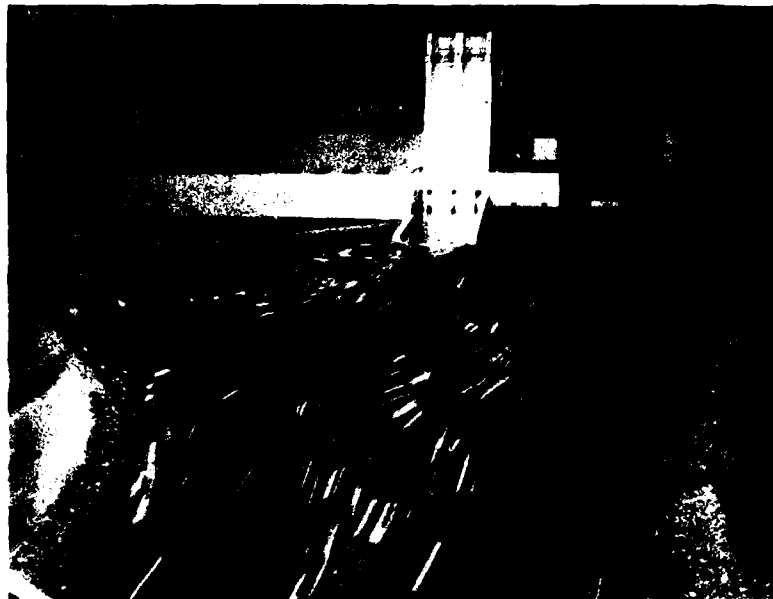
Discharge 60,000 cfs

Discharge 82,000 cfs

Photograph 16. Flow conditions during first-step, second-stage diversion.

51. Velocities on the banks during first-step, second-stage diversion are shown on plates 50 to 52. Flow conditions are shown in photographs 16 and 17. Almost no movement of the initial channel bed occurred with the flow of 20,000 cfs. With 30,000 to 50,000 cfs, bed movement was slight and stabilized in less than 4 hours. With 60,000 cfs, the scour did not stabilize in 10 hours and individual derrick stones on the left bank were dislodged. Just downstream from the two lowest monoliths scour depth extended to bedrock. After the 82,000-cfs flow, scour along the left bank exposed the toe of the derrick stone

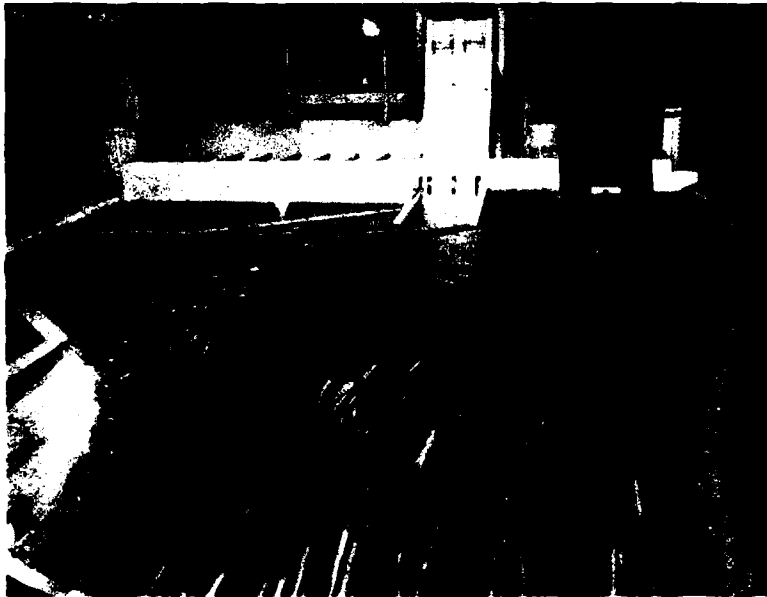
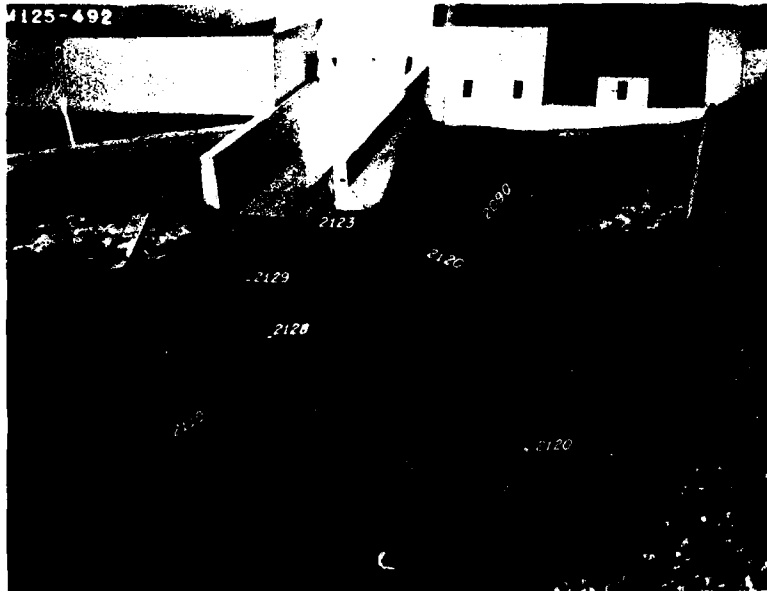
Flow conditions

Scour and deposition after 10 hours

Photograph 17. First-step, second-stage diversion.
Discharge 109,000 cfs.

downstream from the wall; however, no failure of the bank protection occurred. At 100,000 and 109,000 cfs the derrick stone withstood the flow, but scouring occurred on the stilling basin runout slope downstream from the derrick stone (photograph 17).

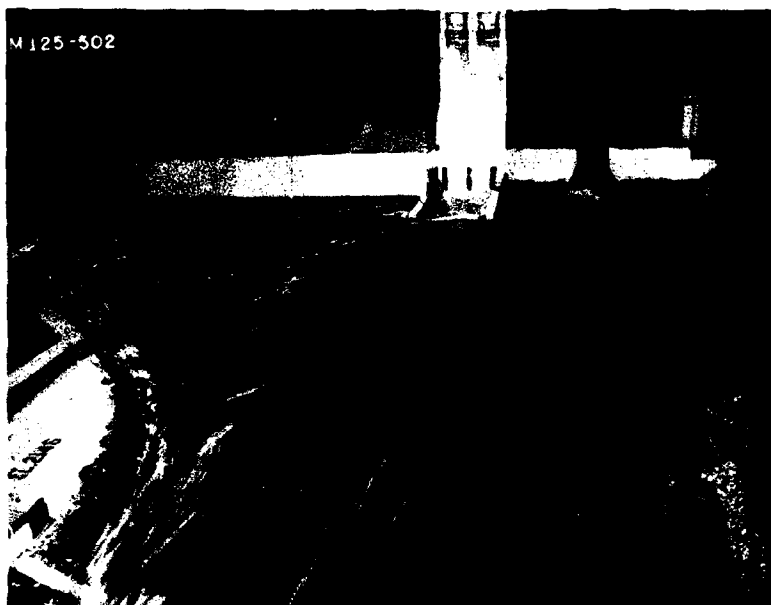
Photograph 19. Flow conditions during second-step, second-stage diversion. Discharge 109,000 cfs.

52. During second-stage diversion (photographs 18 and 19), the higher concentration of flow from Monolith 33 moved the scour pattern downstream and to the right. With flows to 82,000 cfs, a small amount of fine material was deposited in the stilling basin (photograph 20). Deposition occurred in the prototype stilling basin during diversion. Most, but not all, of the debris was removed prior to use of the basin. The debris that was left apparently contributed to the subsequent erosion of the basin. The deposition in the stilling basin ceased at 109,000 cfs, and derrick stone was washed away near the corner of the stilling basin wall (photograph 21). Since the basin wall was to be founded on solid rock, this erosion would not endanger the structure. The maximum velocity over ungrouted derrick stone on the banks was 15 fps (plates 53 to 55).

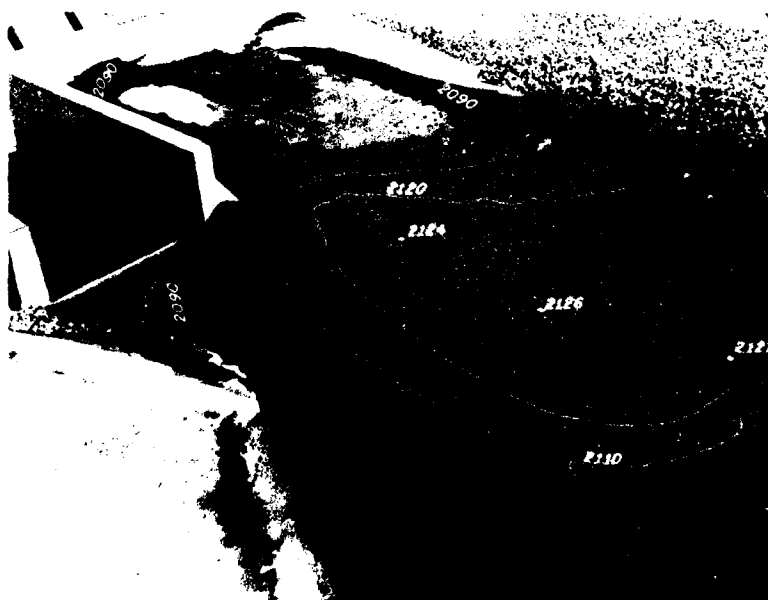
Photograph 20. Scour and deposition at stilling basin after 10 hours of flow with 82,000 cfs during second-step, second-stage diversion.

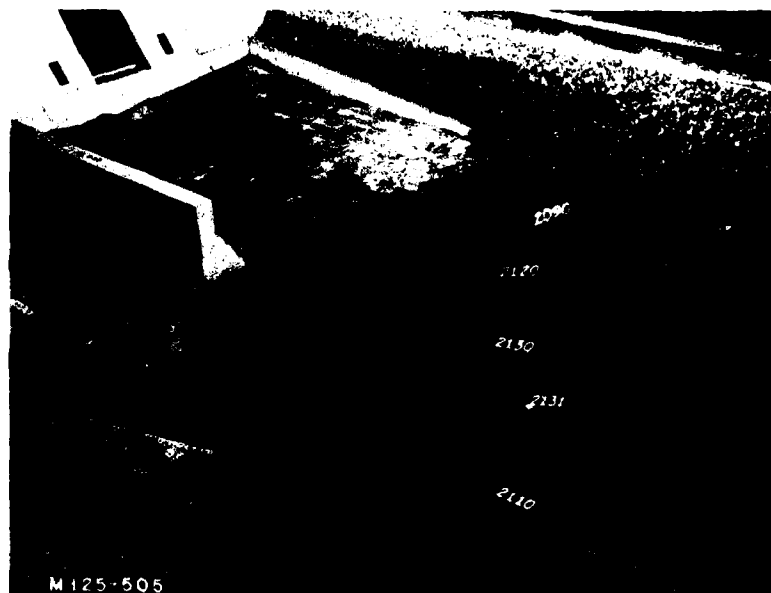
Photograph 21. Scour and deposition at stilling basin after 10 hours of flow with 109,000 cfs during second-step, second-stage diversion.

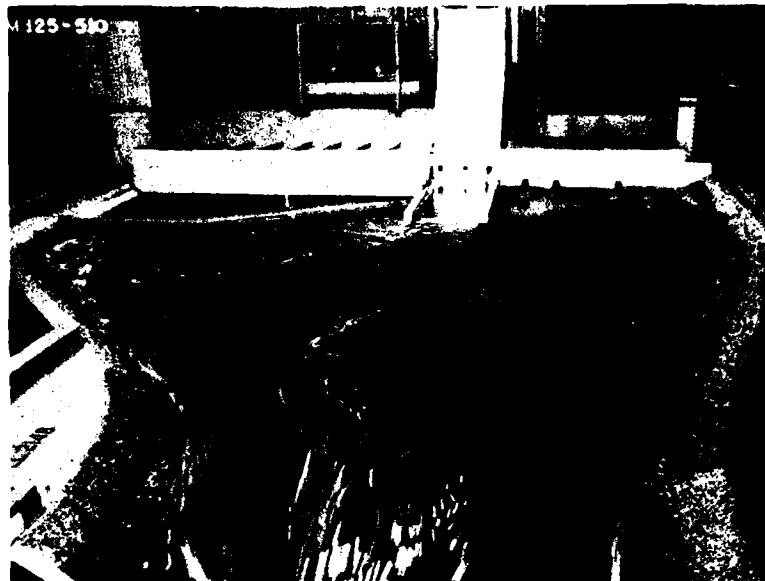
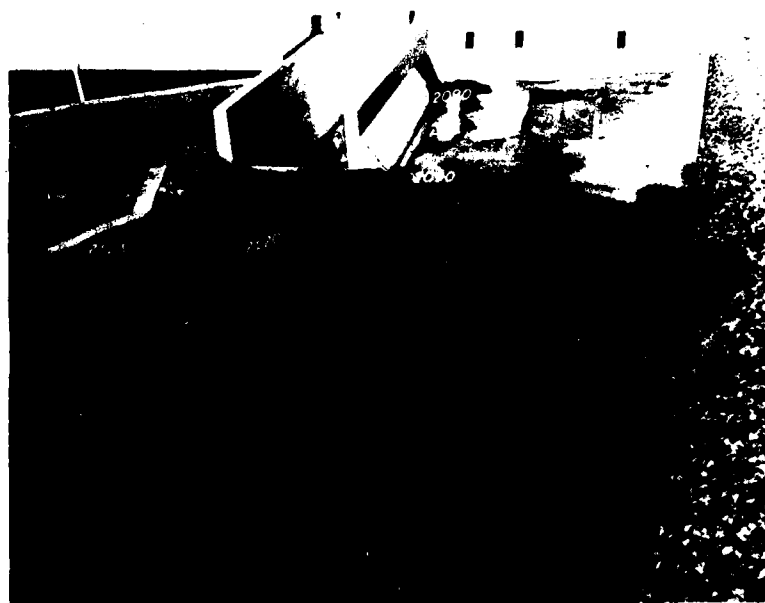
Flow conditions

Scour and deposition after 10 hours

Photograph 23. Third-stage diversion. Discharge 30,000

53. Bank velocities were low (plates 56 and 57), and only minor erosion occurred during the low flows of third-stage diversion (photographs 22 and 23). Almost all movement was along the right side. Material deposited downstream from Monolith 31 was moved into the scoured area downstream from the stilling basin by flows of 10,000 to 20,000 cfs and on downstream by 30,000 cfs (photograph 23).

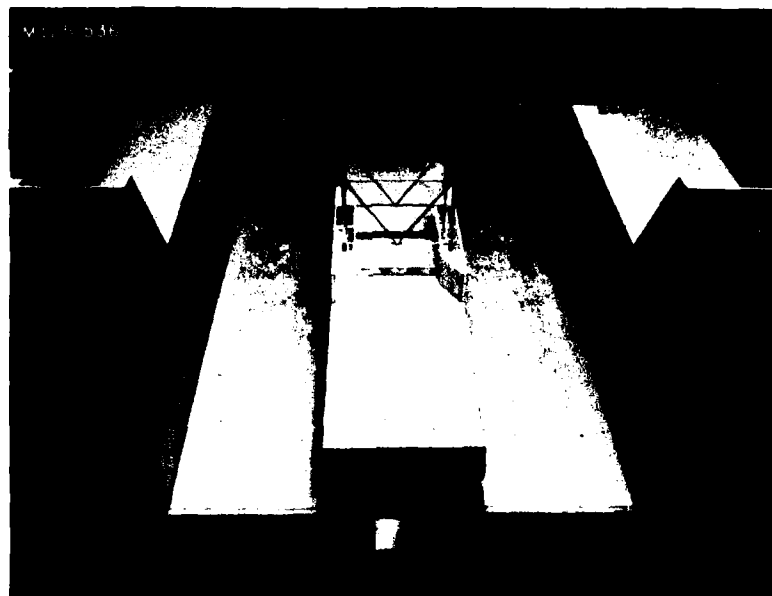
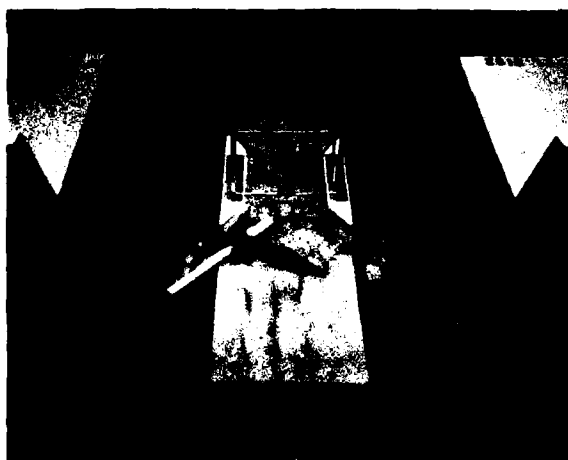
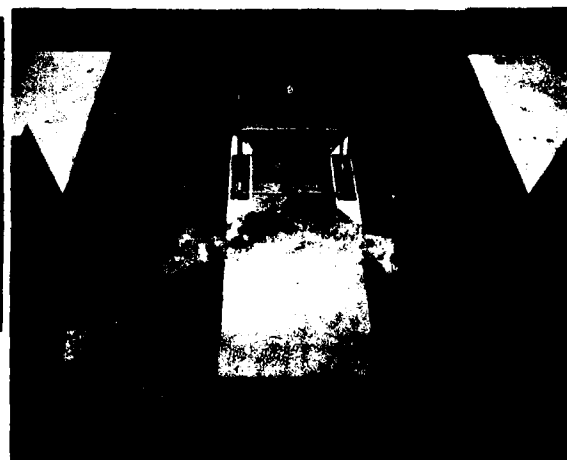
View from upstream

Discharge 109,000 cfs

Discharge 130,000 cfs

Debris caught on deflector piers and tower

Photograph 24. Low monoliths 33 to 35 and contractor's debris deflectors and tower, first-step, second-stage diversion.

57. The adopted plan included two 15-foot-high concrete piers that encased the tower legs (photograph 24 and plate 60). Each pier served as a deflector and would become part of the mass concrete of the monolith. Debris that caught on the long pier noses could be dislodged or removed by means of overhead cranes. Flow around the piers was satisfactory. Debris caught on a pier nose and on a cross

member of the model tower is shown in photograph 24. The piers had no significant effect on the forebay elevation during a riverflow of 109,000 cfs. Maximum rideup of waves on the piers was 14 feet.

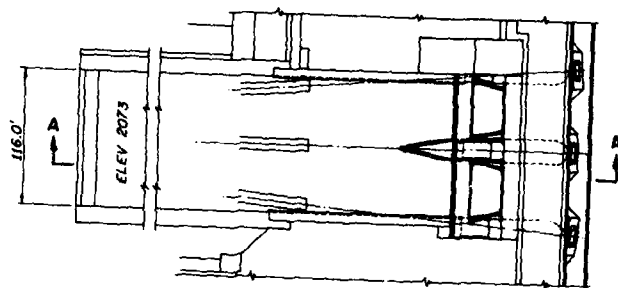
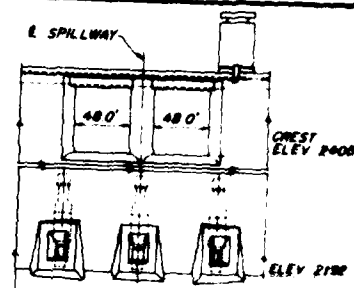
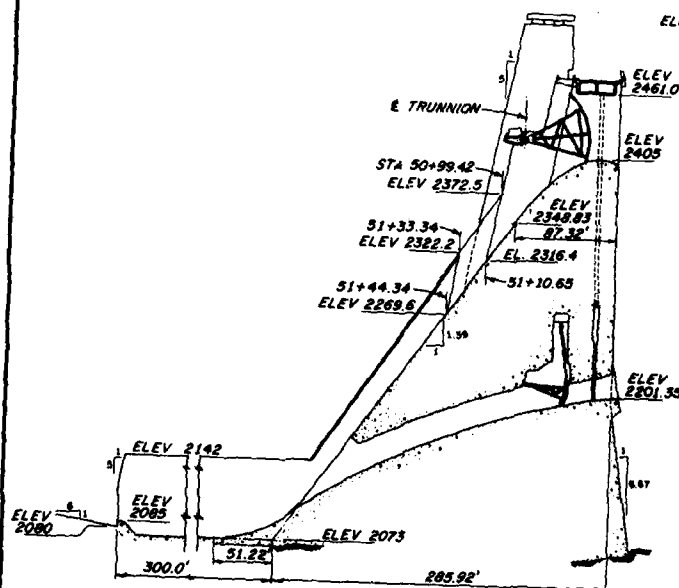
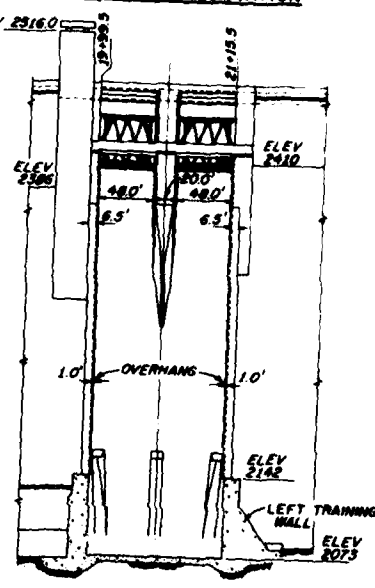
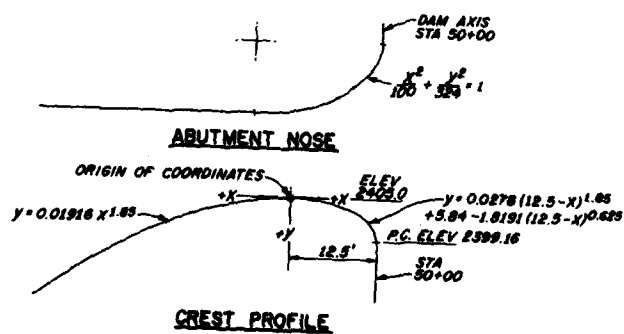
DETAILS
PLAN A CREST, PIER, AND ABUTMENTS

PLAN

UPSTREAM ELEVATION

SECTION A-A

DOWNSTREAM ELEVATION

PLAN OF PIER AT ELEV 2461.0

ABUTMENT NOSE

CREST PROFILE

SPILLWAY DETAILS

NOTES: 1. Details of crest are shown on plate 8.

2. Details of pier and abutments are shown on plate 16.

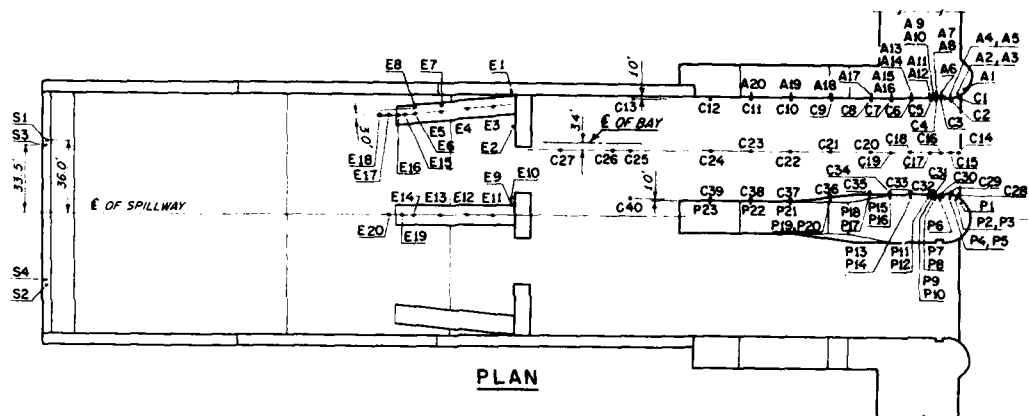
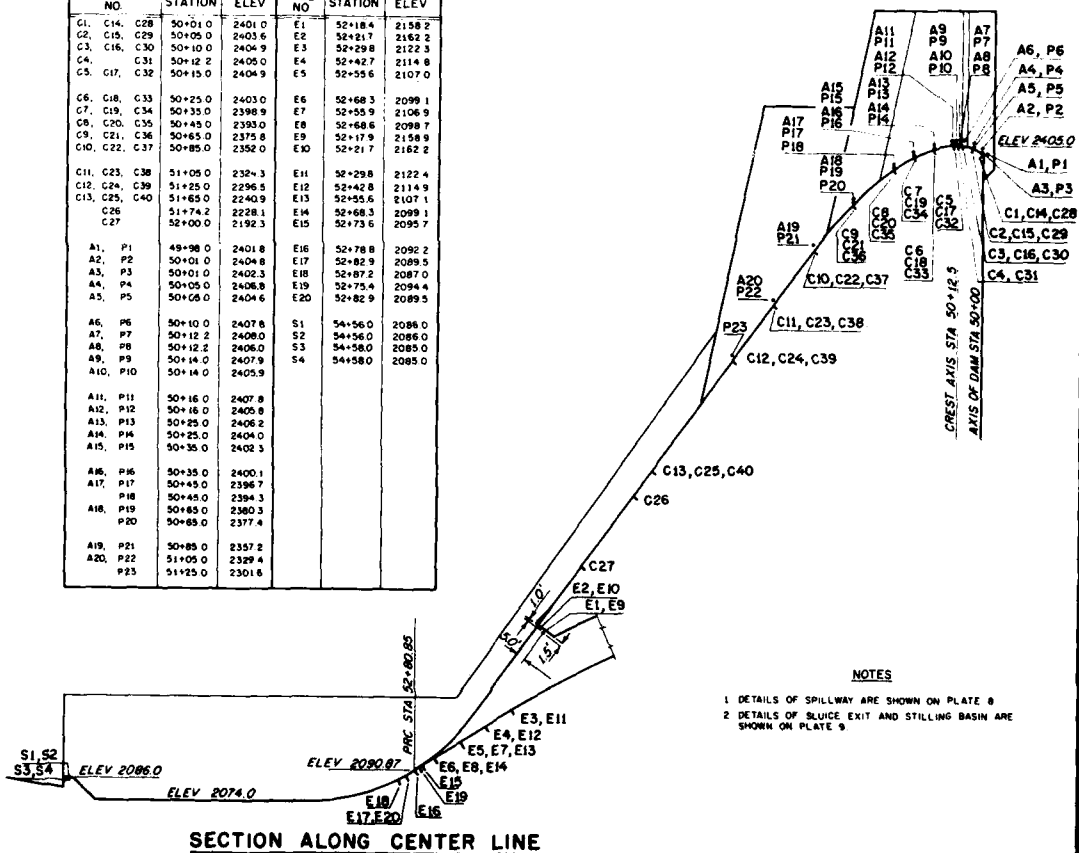
PIEZOMETER LOCATIONS
PLAN A SPILLWAY

PLAN

SECTION ALONG CENTER LINE

- NOTES
1. DETAILS OF SPILLWAY ARE SHOWN ON PLATE 8.
 2. DETAILS OF SLUICE EXIT AND STILLING BASIN ARE SHOWN ON PLATE 9.

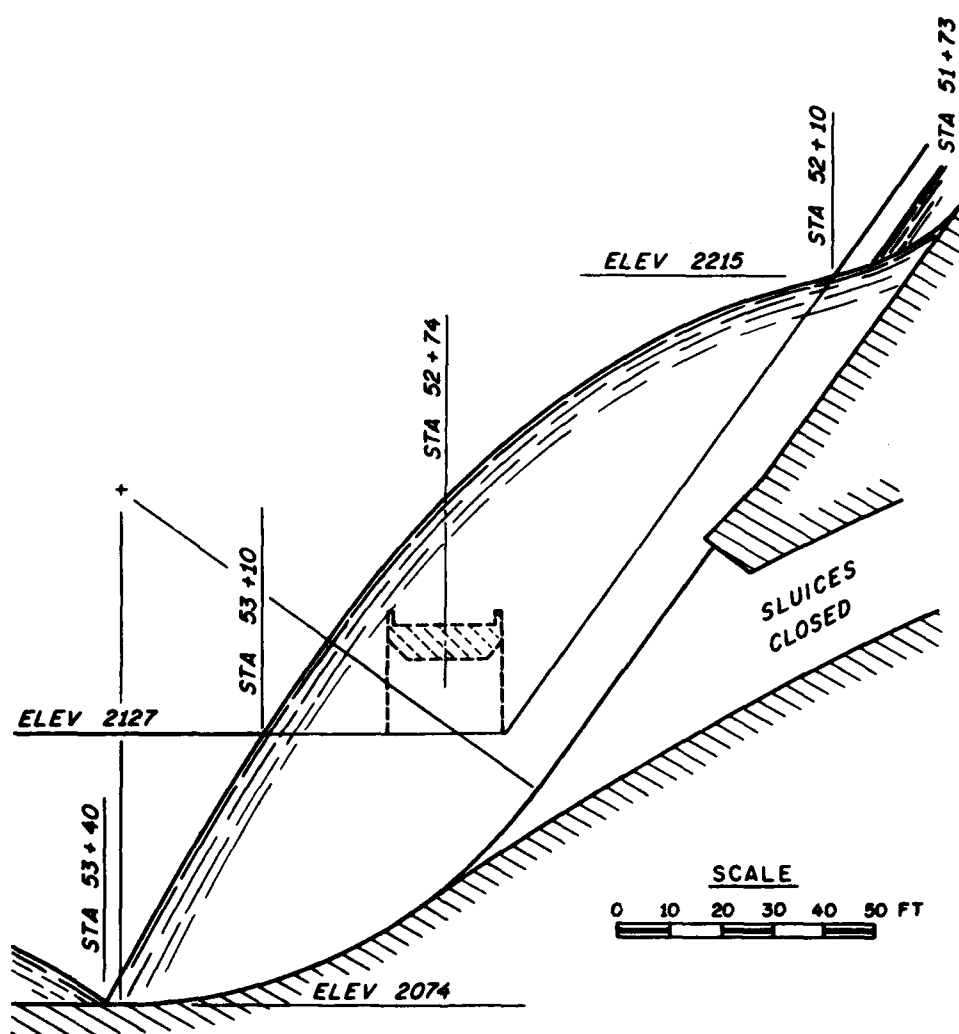
SECTION ALONG CENTER LINE OF SPILLWAY

ROOSTER TAIL IN CHUTE
 SPILLWAY DISCHARGE 145 000 CFS
 PLAN A STRUCTURES

1. DETAILS OF STILLING BASIN SHOWN ON PLATE 9.
2. DETAILS OF CHANNEL AND LOCATION OF TAILWATER GAGE SHOWN ON PLATE 4.
3. FOREBAY ELEV 2459.

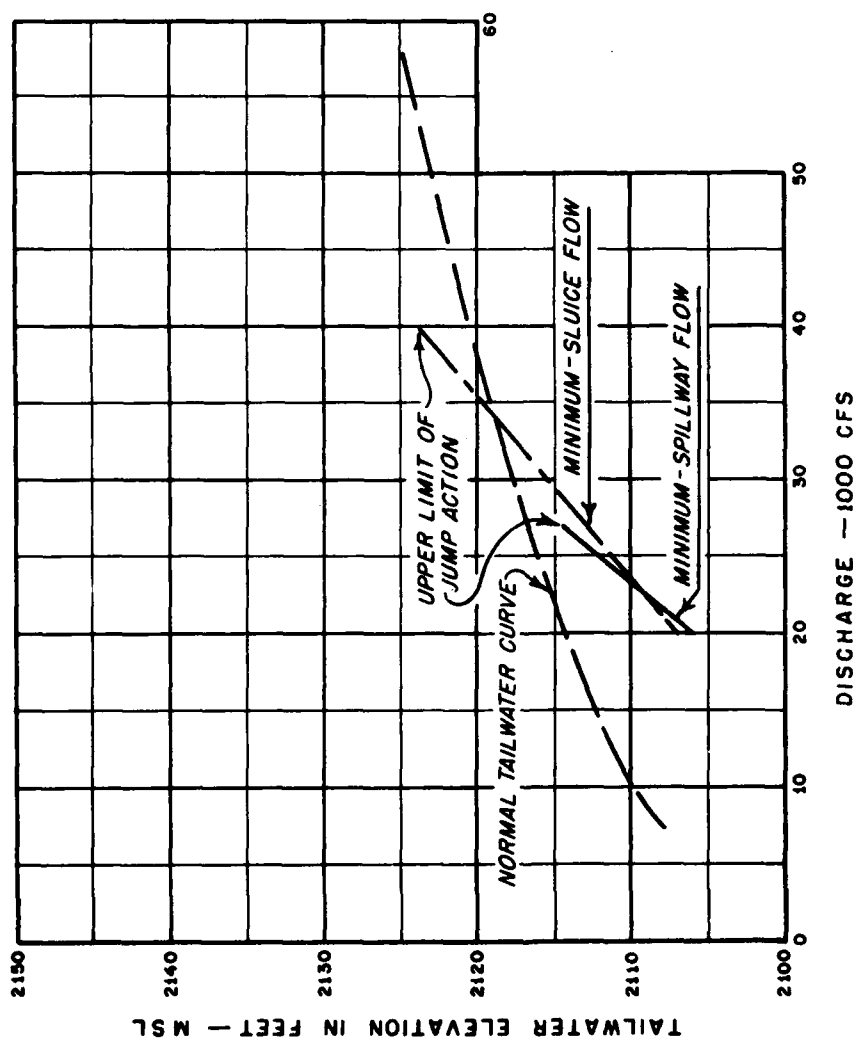
MINIMUM TAILWATER
FOR HYDRAULIC JUMP
PLAN A STILLING BASIN
CHANNEL ELEV 2097

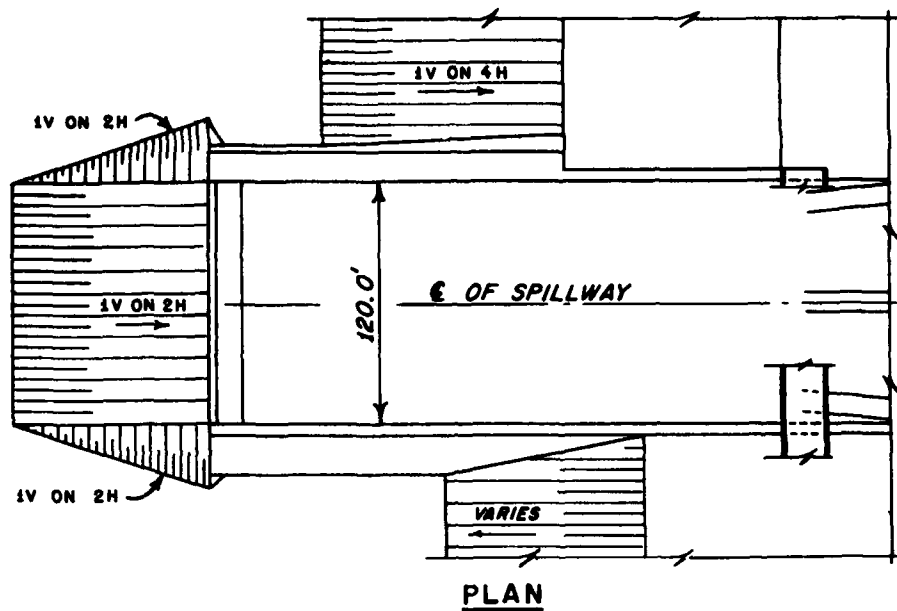
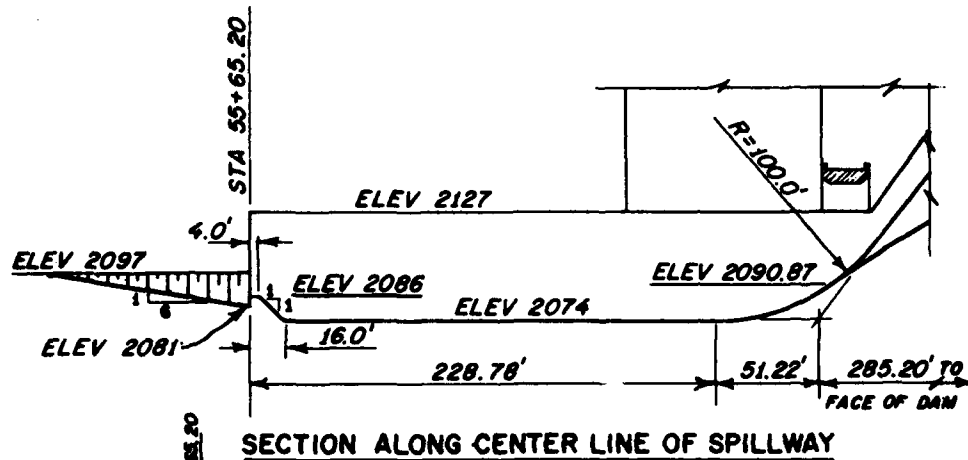
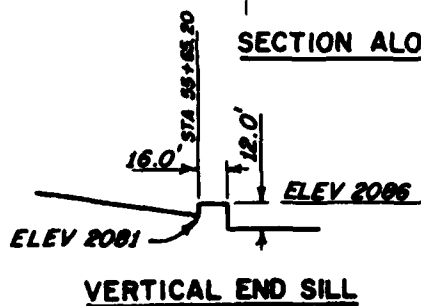
DETAILS
PLAN B STILLING BASIN

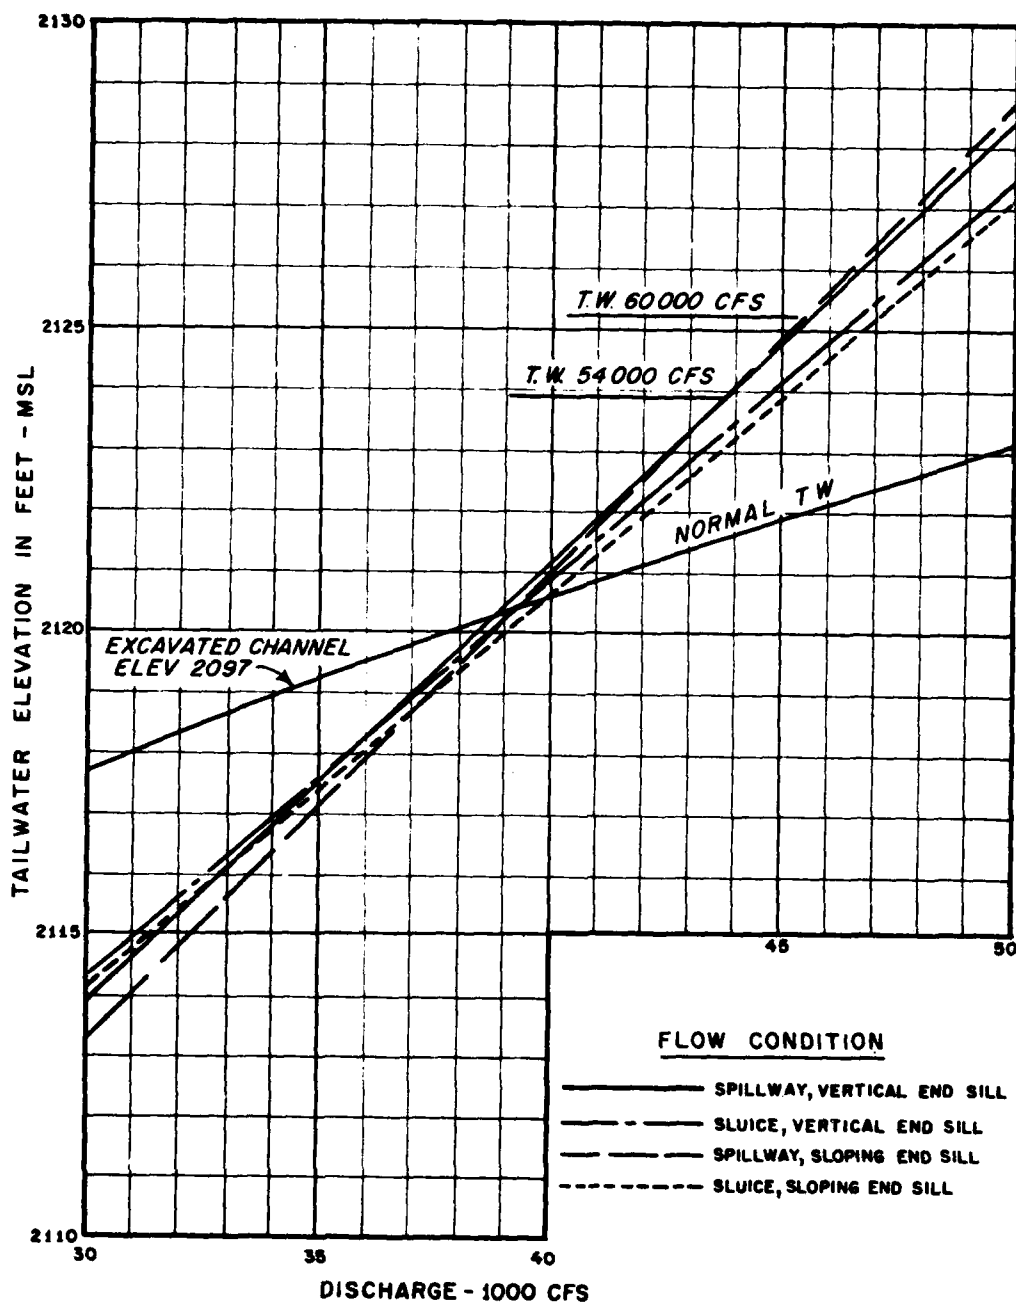
1. DETAILS OF STILLING BASIN ARE SHOWN ON PLATE 14.
2. TAILWATER GAGE LOCATION IS SHOWN ON PLATE 4.
3. FOREBAY ELEVATION 2459.

MINIMUM TAILWATER
FOR HYDRAULIC JUMP
PLAN B STILLING BASIN

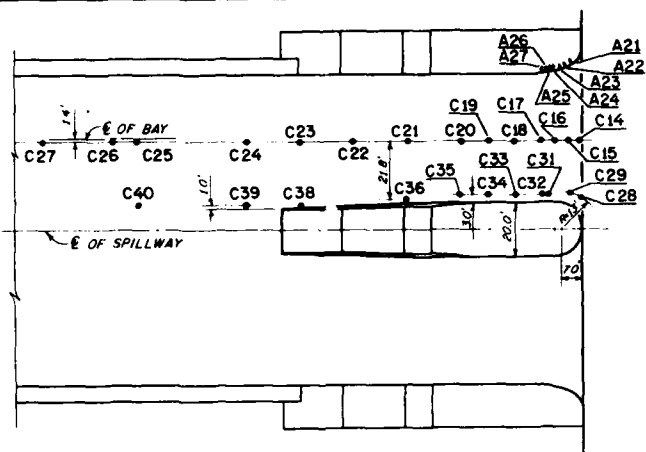
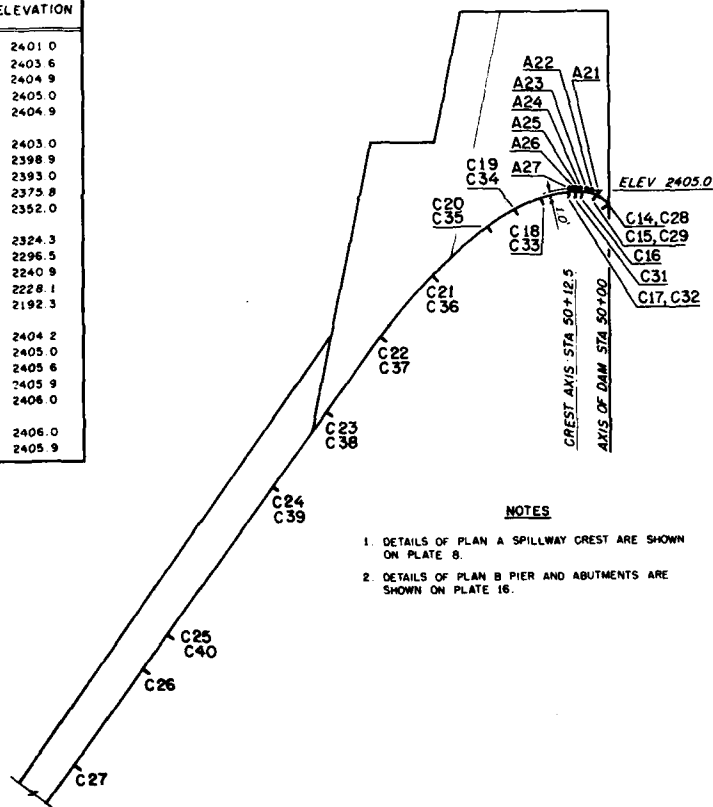
PLAN

1. DETAILS OF PLAN A SPILLWAY CREST ARE SHOWN ON PLATE 8.
2. DETAILS OF PLAN B PIER AND ABUTMENTS ARE SHOWN ON PLATE 16.

PIEZOMETER LOCATIONS
PLAN A CREST
PLAN B PIER AND ABUTMENTS

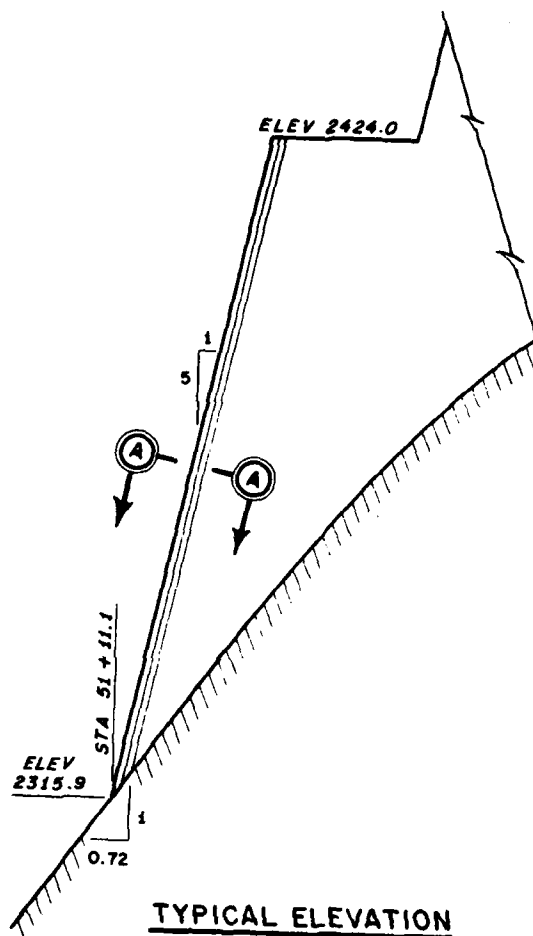
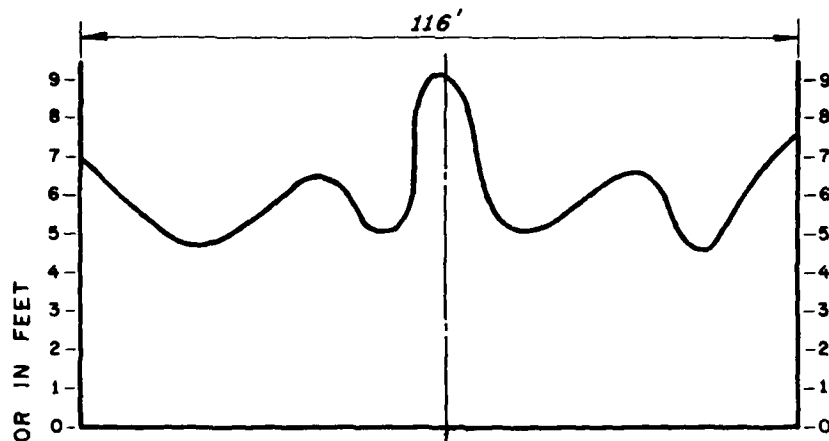
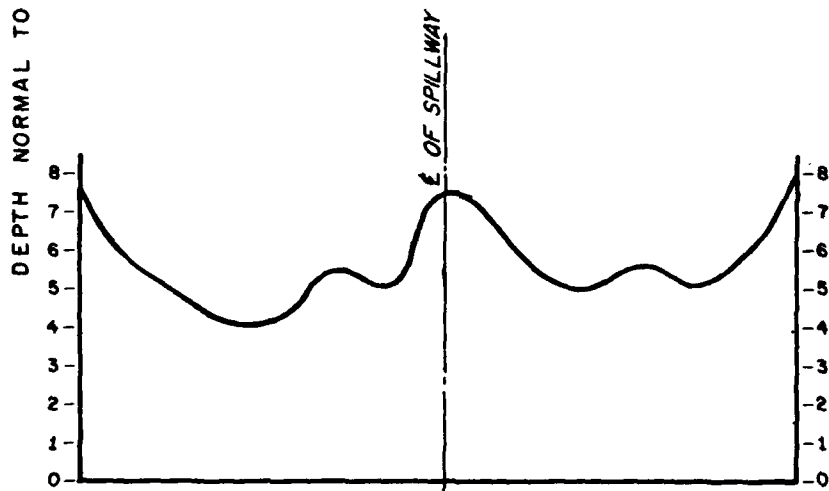
TYPICAL ELEVATION

FLOW DEFLECTORS TESTED
ON PLAN B SPILLWAY PIER

WITHOUT PIER DEFLECTOR

1.0-FT-WIDE, 45-DEGREE, 5-ON-1 SLOPE DEFLECTOR

1. DETAILS OF STILLING BASIN, PIER AND PIER DEFLECTORS SHOWN ON PLATES 16, 17 AND 22.
2. PROFILES TAKEN UPSTREAM OF HYDRAULIC JUMP.
3. FOREBAY ELEV 2459.

FLOW PROFILES AT STATION 54+00

PLAN C STILLING BASIN
PLAN B SPILLWAY STRUCTURES

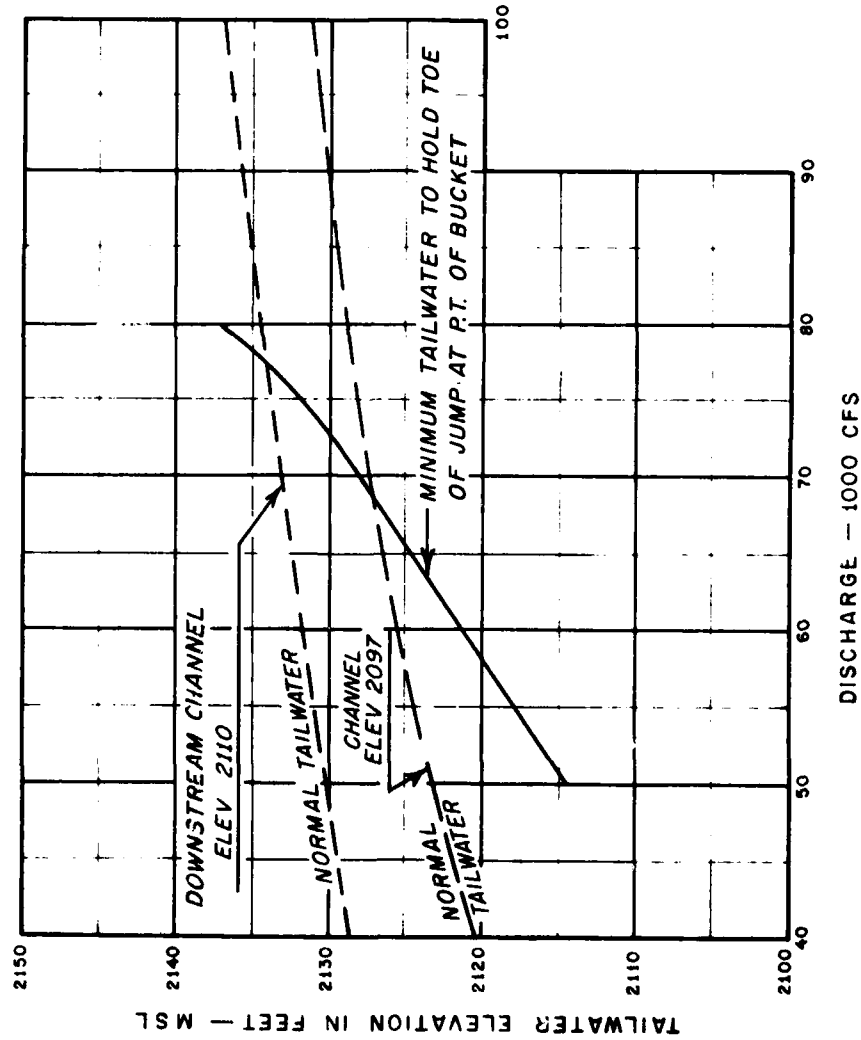
MINIMUM TAILWATER FOR HYDRAULIC JUMP

PLAN C STILLING BASIN
CHANNEL ELEVATIONS 2110 AND 2097

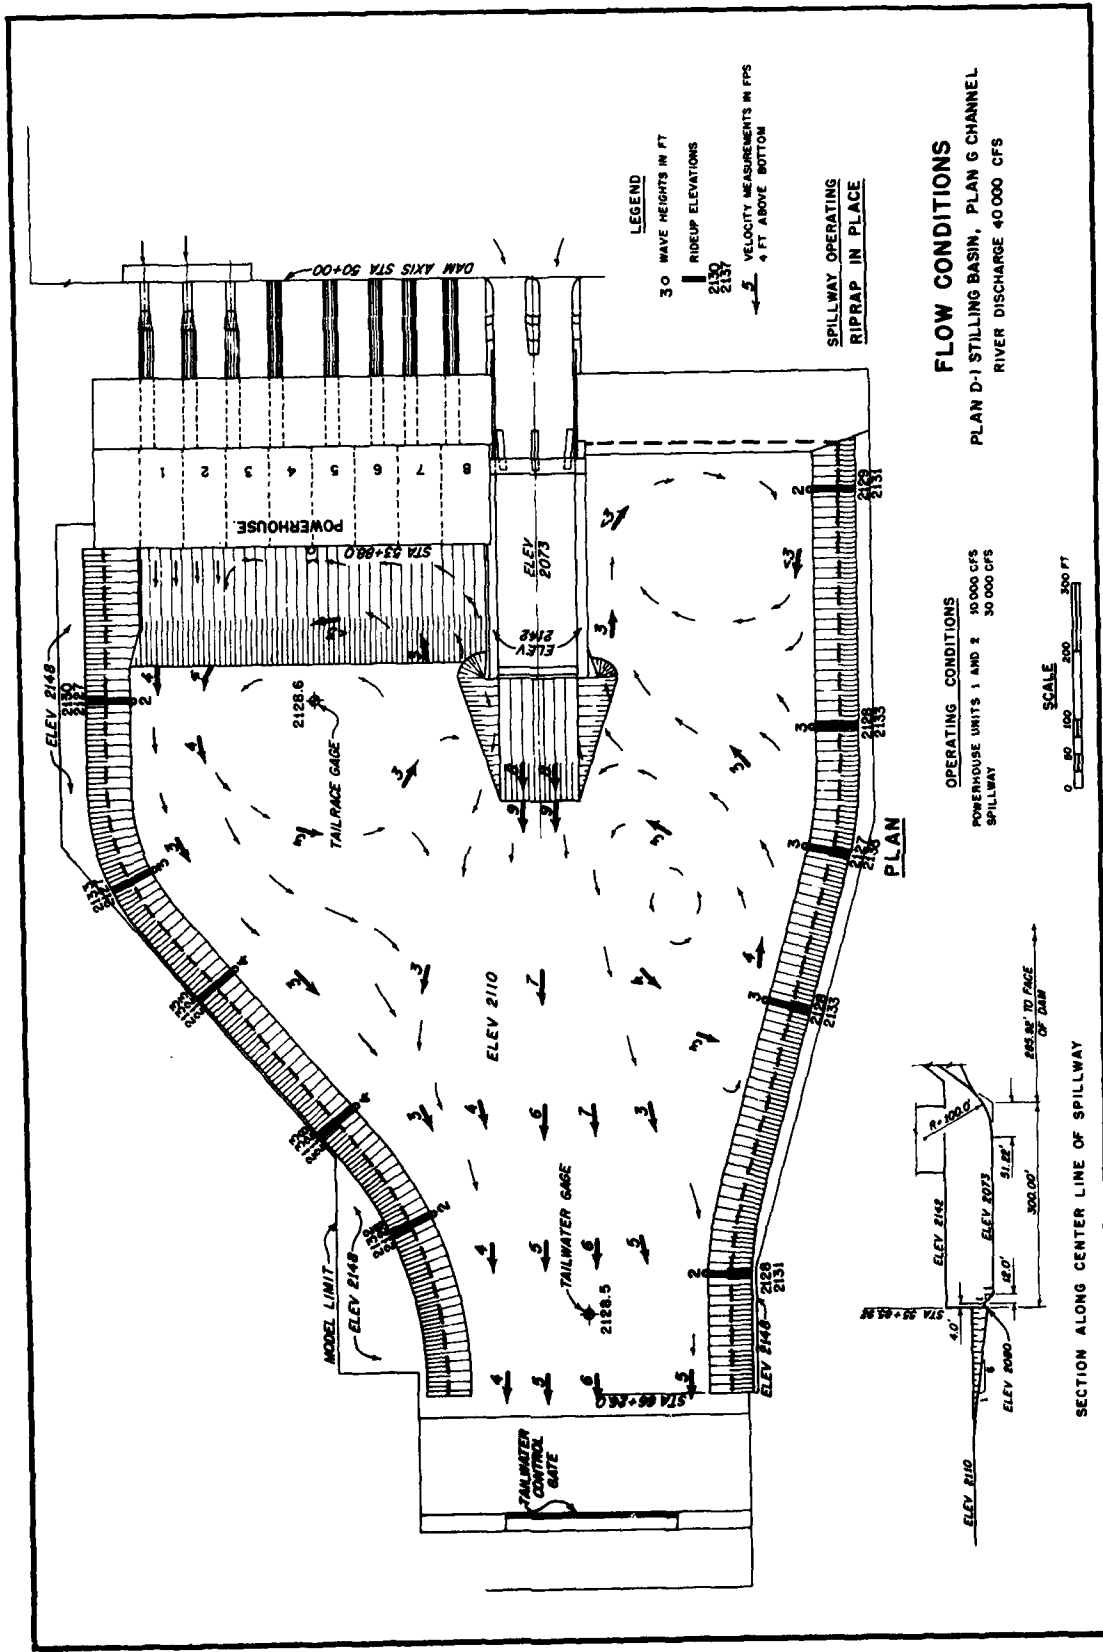
FLOW CONDITIONS
 PLAN D-1 STILLING BASIN, PLAN G CHANNEL
 RIVER DISCHARGE 40 000 CFS

OPERATING CONDITIONS
 POWERHOUSE UNITS 1 AND 2 10 000 CFS
 SPILLWAY 30 000 CFS
